PREFACE

The Report for the year ended 31 March 2007 has been prepared in three volumes (PA 8 of Performance Audit, CA 6 of Compliance Audit and PA 18 of Information Technology Audit) for submission to the President under Article 151 (1) of the Constitution of India.

Chapter 1 Disaster Management in Indian Railways

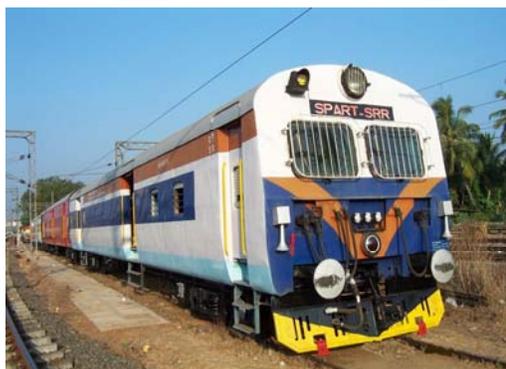
- The stock register of SPART at Chennai Division of SR revealed disposal of various items as 'rat damaged'. Rusty surgical equipments requiring replacement were available and the expiry dates of medicines were incorrectly exhibited.

- Further, on two occasions of major accidents, the SPART located at Chennai Division of SR, which was self propelled, had to be hauled with the assistance of a locomotive. Similarly, during a trial run, the SPART at Palghat Division of SR could not be moved due to an error in its engine, indicating that the SPARTs were not maintained in good fettle.

The SPART at Chennai Division

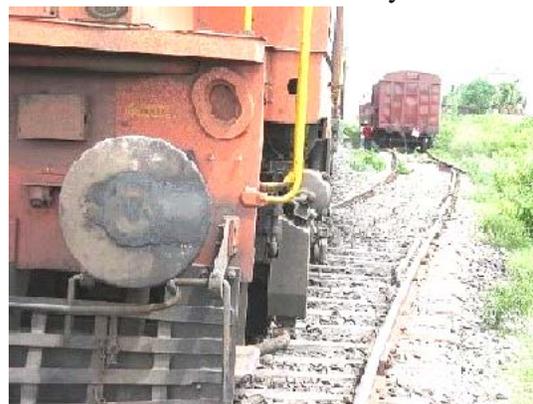
In ECoR, the ART placed at Talcher siding could move only in the forward direction and had to take a route, which was invariably occupied by goods trains blocking the exit point of the ART. In ECR, an ARMV was placed at Jhanjharpur and all the staff deployed on this ARMV

Pathway of ART blocked by a goods train at Talcher Station

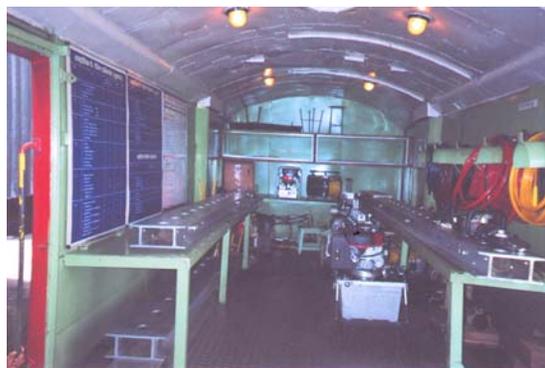
ART Kurla carrying hydraulic rerailling equipment

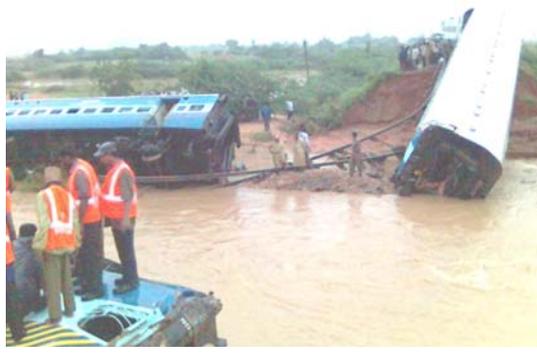
- In the derailment of train no 415 Delta Fast Passenger at 04:22 hours on 29 October 2005 between block stations Ramannapet -Valigonda at a bridge on SCR, where the train fell into a water flowing underneath the bridge, the rescue team could not maneuver the velocity of the flowing water and though the ARMV from Secunderabad reached the site by 6:50 hours, the

The capsized Delta fast passenger train in Valigonda

rescue work could commence only at 09:30 hours, after the water level receded, with the assistance of the local villagers. The passengers from other coaches helped those in the affected coaches to come out.

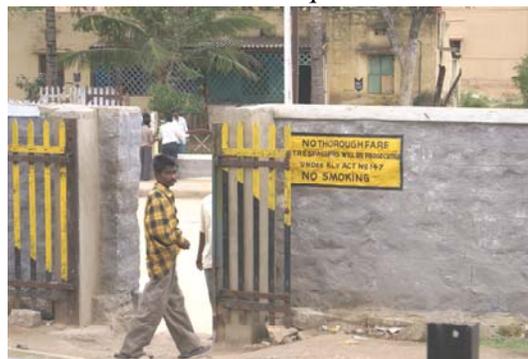
- A majority of the stations had multi entry/exit points, which were either not manned or monitored regularly. The RPF was therefore not effective in preventing unauthorized entry into station premises.

An unmonitored entry/exit point at Bangarapet station
