PREFACE

The Report for the year ended 31 March 2007 has been prepared in three volumes (PA 8 of Performance Audit, CA 6 of Compliance Audit and PA 18 of Information Technology Audit) for submission to the President under Article 151 (1) of the Constitution of India.

Chapter 1 Disaster Management in Indian Railways

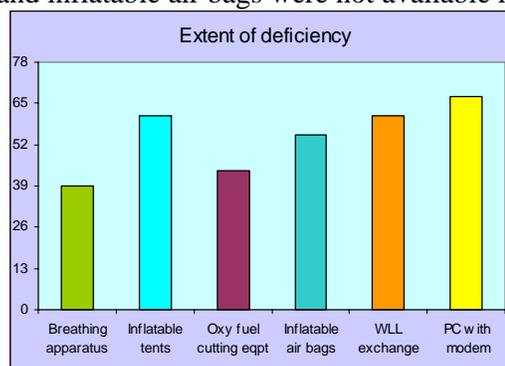
- Equipment such as self contained breathing apparatus, inflatable tents, oxy fuel cutting equipment and inflatable air bags were not available in 39, 61, 44 and 55 ARTs respectively.

- Equipment facilitating maintenance of communications such as WLL exchange and PC with high speed satellite modem was not available in 61 and 67 ARTs respectively. Further, the WLL exchange was not commissioned in four ARTs and the PC was without the modem in two ARTs.

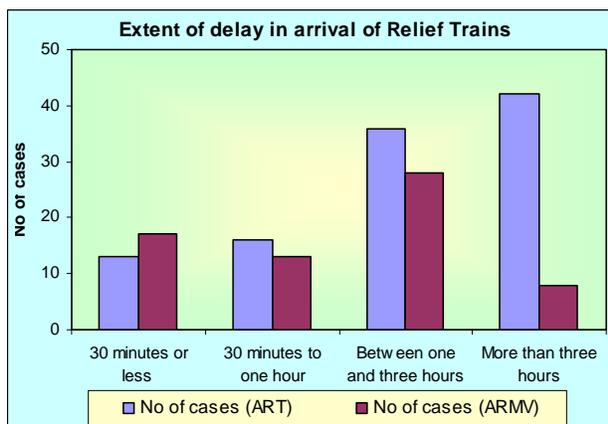
- The time required for ordering and movement of the ARTs/ARMVs together with the requisite time to travel the distance to the disaster site invariably took the response time beyond the golden hour. Out of the 138 incidents that

warranted either an ART or an ARMV for rescue and relief, in 124 cases the ART/ARMV the site after the golden hour. The assistance provided by IR during the golden hour was thus more by default than by design. For instance, in an accident involving a truck and train no 9304 Bhopal–Indore Intercity express at Ujjain station in Ratlam Division of WR on 27 June 2004, the ART ordered at 20:30 hours, departed only at 21:54 hours and took 48 minutes to reach the site, which was only six and a half kilometers away. Even during the bomb blasts in seven local trains that took place on 11 July 2006, in Mumbai suburban section of Mumbai Central Division of WR the ARMVs located at Mumbai Central, Valsad and Udhana were ordered but before arrival of the ARMVs, the victims at all the locations had already been shifted to nearby hospitals by the volunteers from amongst the passengers and medical relief was not required to be done by the ARMVs. Due to non-availability of diesel locomotive in the vicinity of 75 Kilometers on Mumbai Division, ARMV capable of running at a speed of 100 Kilometers per hour had to be hauled with WDS 4 locomotive with a speed capacity of 45 Kilometers per hour only.
